Manhole Inspection Summary

Manhole # S25C__026MH

Insp Date: **8/6/07 7:57 AM**

Location Address: **501 CARROLTON AVE**

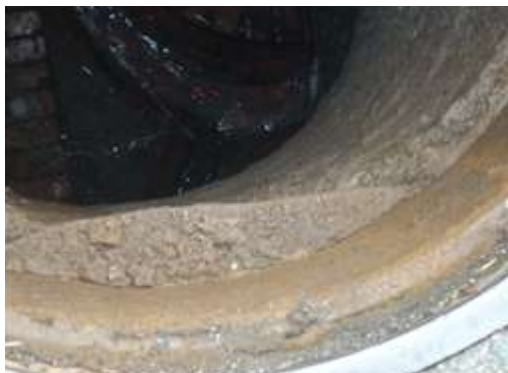
Defect 4

Offset: **2** (in.)

FRAME OFFSET

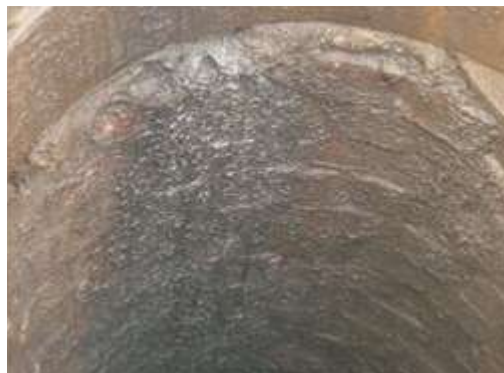
Defect 3

Infiltration: ☐ None ☒ **Joint** ☐ Cracks ☐ Mortar ☐ Roots ☐ Wall

INFILTRATION OF CHIMNEY

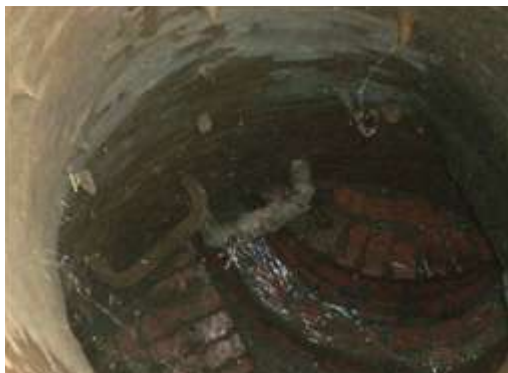
Defect 2

☒ **Evidence Of Surcharge** Depth: **2** (ft.) ☐ Active Surcharge Present

SURCHARGE EVIDENCE ON BOTTOM STEP

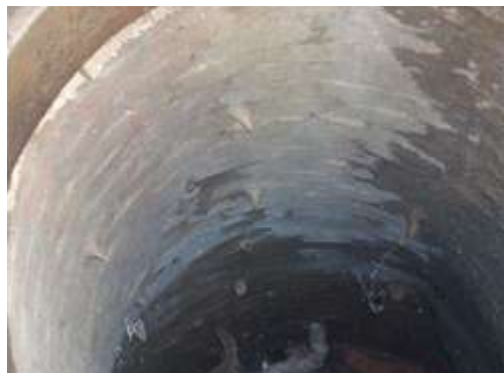
Defect 1

Count: **4** Missing: **2** ☒ **Corroded**

MISSING AND CORRODED STEPS

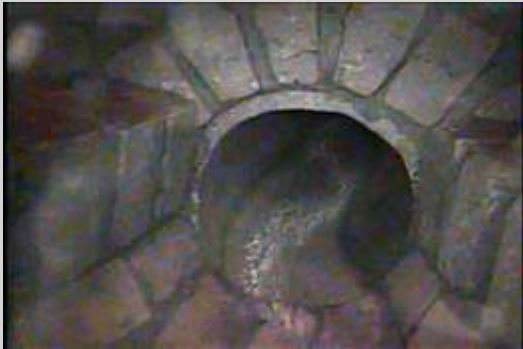
12 O'Clock Outflow

8 in. Circular Gravity Sewer
Pipe Out @ 12 O'Clock

Pipe Height: **7.2** (in.) Rod and Bar (Angled)
Pipe Material: **Clay** ☐ Pipe Lined
Invert Depth: **11.42** (ft.) Flow Characteristics: **Slow**
Deposits: ☒ None ☐ Mud ☐ Sludge ☐ Debris ☐ Grease
Silt Depth: (in.) Deposits Extent:
Infiltration: **None** Pipe Seal Cond: **Sound**

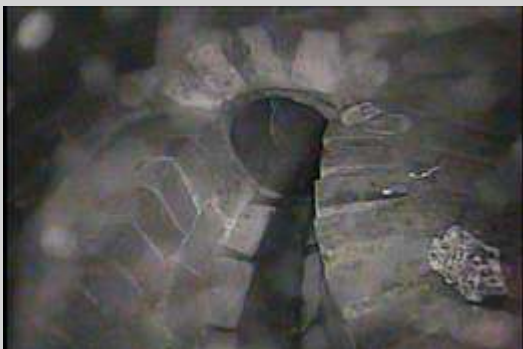
6 O'Clock Inflow

8 in. Circular Gravity Sewer
Pipe In @ 6 O'Clock

Pipe Height: **7.2** (in.) Rod and Bar (Angled)
Pipe Material: **Clay** ☐ Pipe Lined
Invert Depth: **11.27** (ft.) Flow Characteristics: **Slow**
Deposits: ☒ None ☐ Mud ☐ Sludge ☐ Debris ☐ Grease
Silt Depth: (in.) Deposits Extent:
Infiltration: **None** Pipe Seal Cond: **Sound**

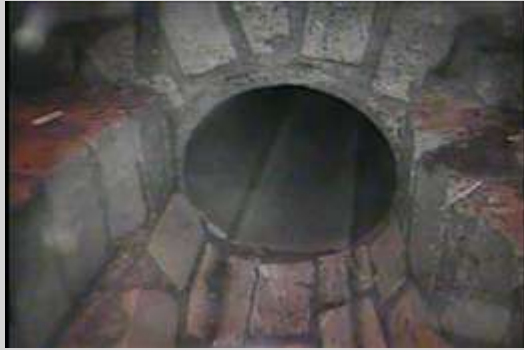
9 O'Clock Inflow

8 in. Circular Gravity Sewer

Pipe In @ 9 O'Clock

Infiltration: **None** Pipe Seal Cond: **Sound**
